CERTIFICATE OF APPROPRIATENESS PLACARD

1024 DOROTHEA DRIVE

Re: Structural Observation—1024 Dorothea Drive, Raleigh, NC 27603

Project No. 17-069

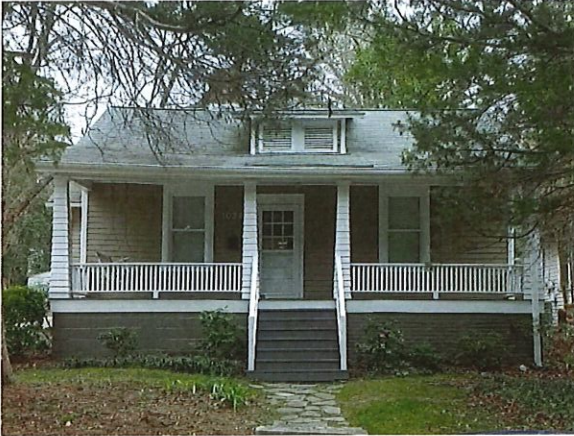
At your request, on Friday, February 3rd, 2017, we performed a visual structural observation of a reported leaning foundation and concerns related to a recently removed tree at the Raleigh residence noted above. The structure is a conventionally framed, detached, one-story, single family residence with raised first floor framing over a pier/girder foundation system with partial perimeter masonry pier/curtain walls and partial perimeter masonry foundation walls (*see picture 1*).

Picture 1 – 1024 Dorothea Drive, Raleigh, NC

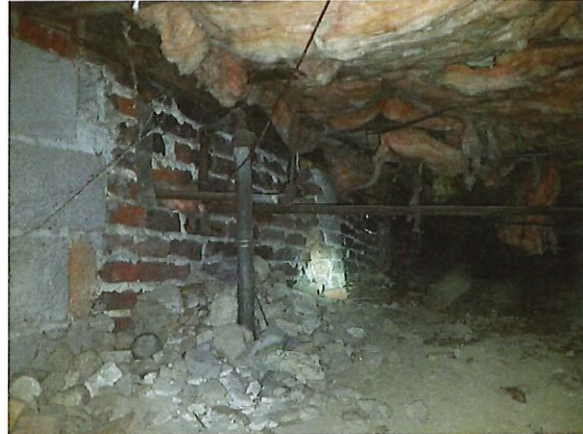
- An approximately 13’ section of the perimeter masonry pier/curtain wall near the front-left of the home was noted to be significantly leaning and in a state of disrepair (*see pictures 2-3, for examples*).
 - A large tree stump was noted adjacent to the leaning section of the perimeter masonry pier/curtain wall.
 - Humps in the floor and a racked interior door were noted within the home adjacent to the area of concern (*see pictures 4-5, for examples*).
 - Additionally, the perimeter rim beam above the damaged portion of perimeter wall was noted to be in disrepair (*see picture 6, for example*).
 - Joists were out-of-contact with the sheathing at various locations along the same area.

- We believe the above-noted damaged portion of the foundation system and first floor framing system have been the result of the large tree near the front-left corner of the structure.

Picture 2 – Example of leaning pier/curtain wall

- Remove the above-noted damaged section of the perimeter masonry pier/curtain wall and replace it with a vented, conventional perimeter masonry pier/curtain wall or foundation wall in accordance with applicable provisions of the *NC Residential Building Code*:

- Install new 8"x16" hollow CMU piers with 4" solid caps centered over 24"x24"x8" thick poured concrete footings set at least 12" into suitable bearing soils at 6' on center max spacing (use approximately equal spacing), and beneath rim beam splice locations.
- Install a 4" (minimum) conventional vented masonry curtain wall around the perimeter of the home over the center of a 12" wide x 6" thick poured concrete footing set at least 12" into suitable bearing soils (mono-pour curtain wall and pier footings).
- Piers and curtain wall elements should be constructed integral with each other.

- Foundation wall should be full height CMU with at least 8" clearance between the top of the masonry wall and the top of the adjacent exterior grade.
- Perimeter footings should be at least 16" wide x 8" thick poured concrete set at least 12" into suitable bearing soils.

- Simpson "Universal Foundation Plates" may be used as a 1:1 replacement for ½" diameter bolts.
- Upon removal of the existing perimeter masonry pier/curtain wall, remove any remaining roots and the tree stump from the area below the location of foundation footings, and fill remaining depressions and voids with properly compacted fill material.

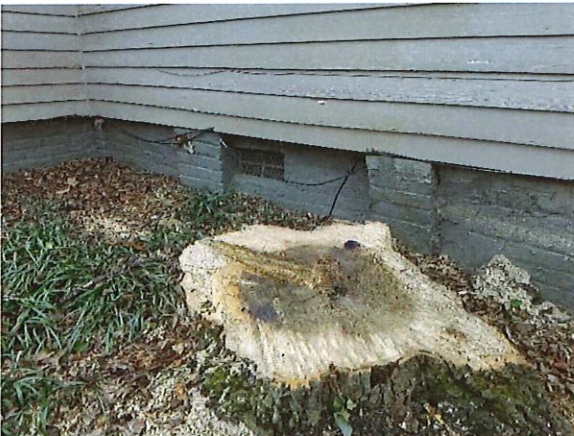
Picture 3 – Example of leaning pier/curtain wall

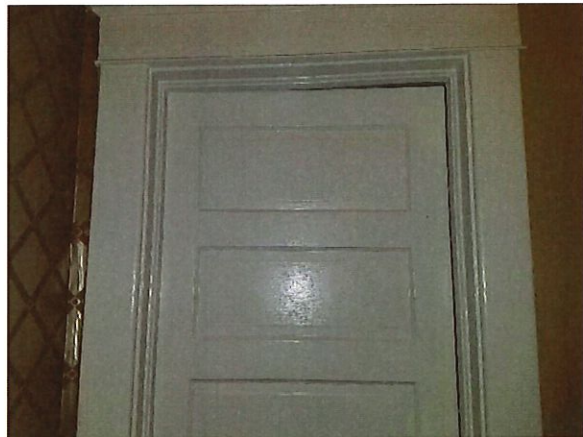
Picture 4 – Racked interior doorway at front room

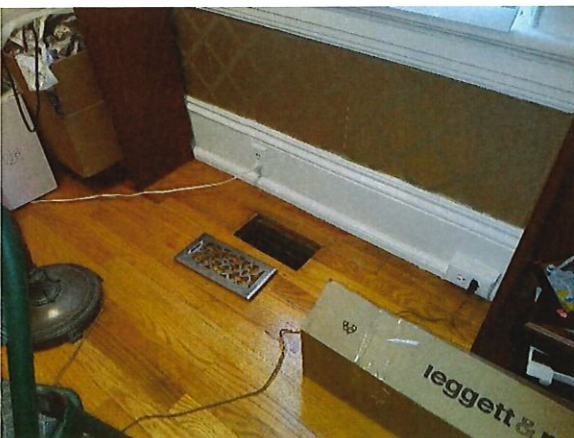
Picture 5 – Hump in floor at front room

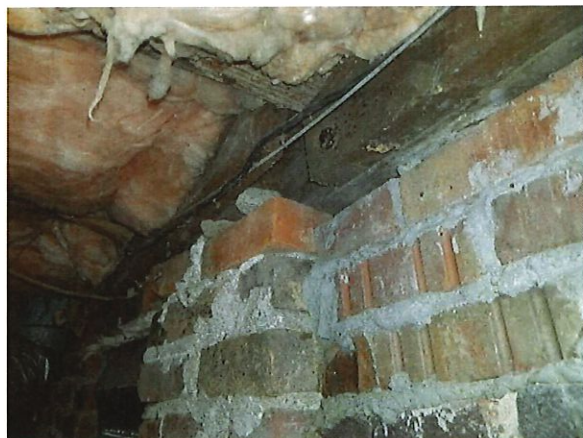
Picture 6 – Damaged perimeter rim beam

- Remove the above-noted damaged section of the perimeter rim beam, and replace it as follows:
 - If the wall is to be replaced with a pier/curtain wall system, remove the damaged section of the perimeter rim beam, and replace it with full depth built-up (3)2x (minimum) treated #2 Southern Yellow Pine (SYP) material. Reattach joists to the faces of the new members using Simpson face hangers. Additional 2x plies may be necessary to match the widths of the removed rims and girders should only be spliced over the centers of piers.

- If the wall is to be replaced with a foundation wall, then the rim beam should be replaced with a full depth 2x rim band, built-up as needed to fill the space at the ends of the floor joists. Joists should be fastened directly to the inside face of the new rim if they have less than 1½" of bearing over the new sill plate.

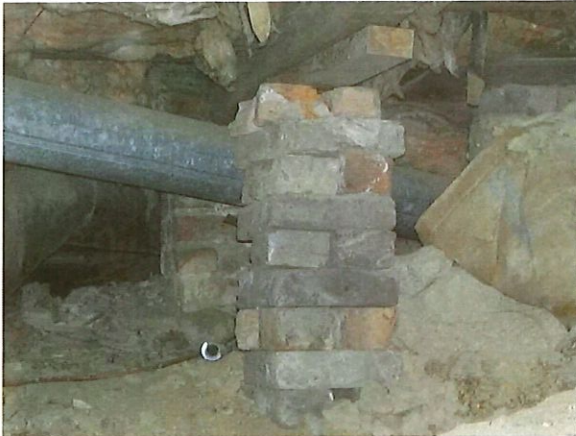
- The (2) front-most piers along the leftmost girder at the front-left of the crawlspace were noted to be haphazard and deteriorated (*see picture 7*).
 - Additionally, the girder was inadequately supported at its front end (*see picture 8*).
- Mortar joints were noted to be deteriorated at various locations throughout the crawlspace.

Picture 7 – Deteriorated masonry piers along leftmost girder

- Remove the and replace the above-noted deteriorated piers and replace them with new 16"x16" hollow CMU piers with solid 4" caps centered over 24"x24"x8" thick poured concrete footings.

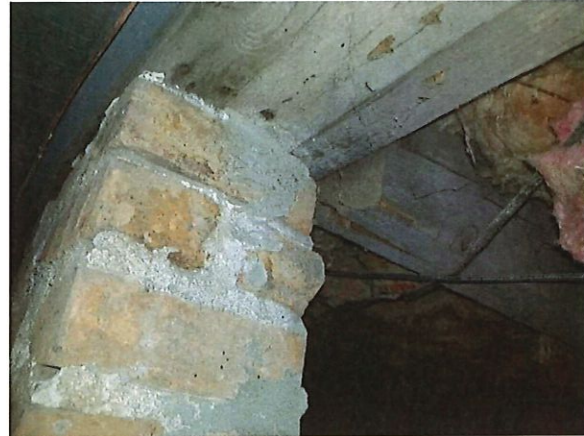
Picture 8 – Inadequate support at front end of leftmost girder

- * ○ Additionally, add a 16"x16" hollow CMU pier with a solid 4" cap centered over a 24"x24"x8" thick poured concrete footing set at least 12" into suitable bearing soils beneath the front-end of the above-noted improperly supported girder.
