# CERTIFICATE OF APPROPRIATENESS PLACARD

934 N Boylan Ave

COA-0203-2018

Subj: 934 N. Boylan window restoration

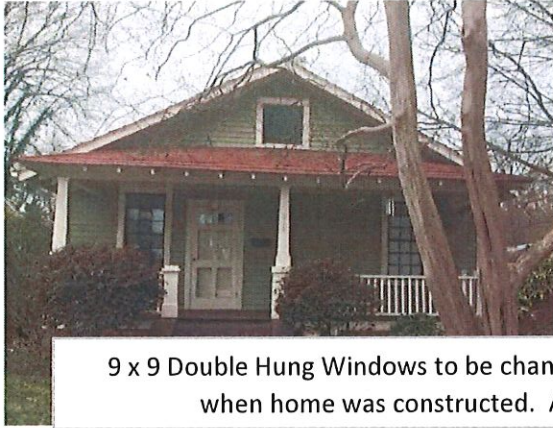
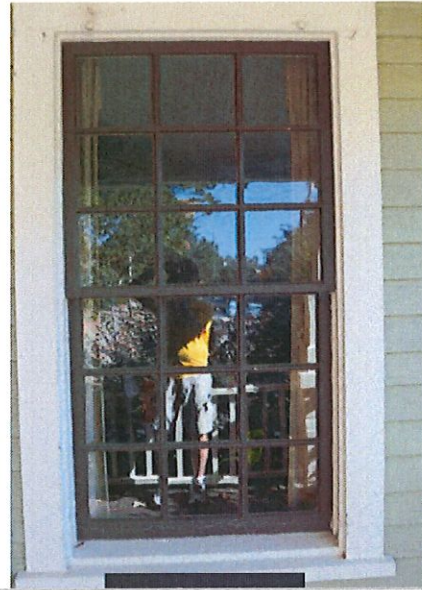
9 x 9 Double Hung Windows to be changed to 9 x 1 type per original design when home was constructed. All trim to remain the same.

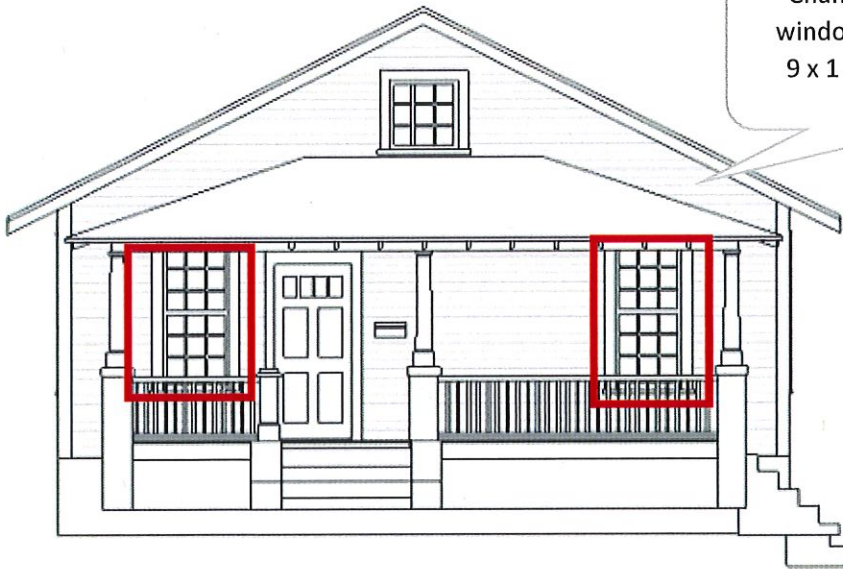
FRONT ELEVATION

Change both 9 x 9 double hung windows on front elevation to be 9 x 1 type. Retain existing trim.

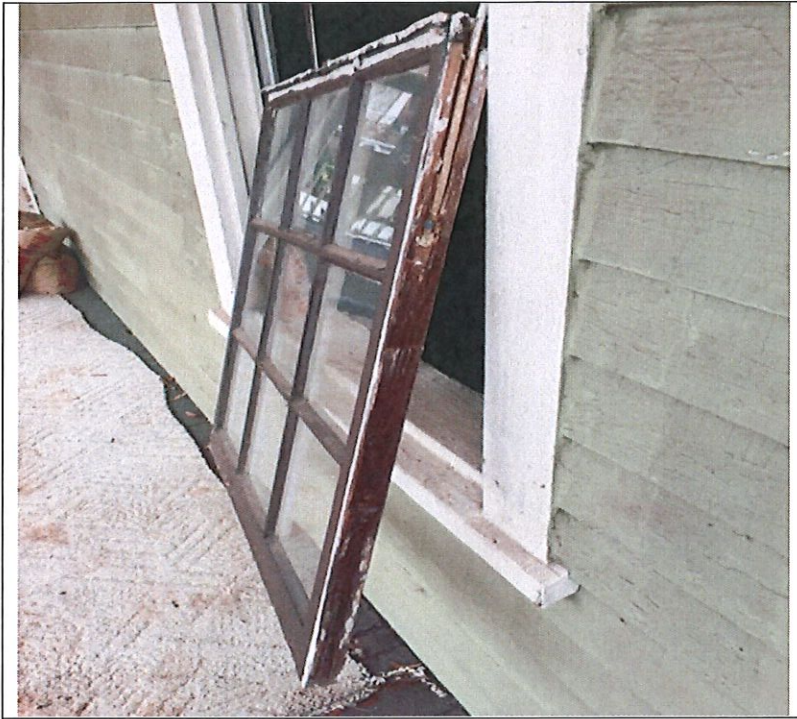
I began my work by removing both sashes from Windows 1 & 2 and taking them home to my workshop. I noticed at the time that the ropes on both lower sashes were attached to the side stiles in crudely-cut channels but at the opposite ends of the stile from the original channels. This meant that the sashes had actually been hanging upside down! This seemed strange at the time but I didn't investigate it any further since I wanted to get them home to start work on them. At home, I noticed 3 additional anomalies: (1) a ~ ½ inch thick strip of wood had been attached to the bottom rail to increase its width, (2) the sash locks were mounted on the opposite side of the meeting rail from where they should be, and (3) the bevel surface on the meeting rail faced in the opposite direction from where it should if it were to mate properly with the bevel surface on the upper sash. To compensate for this, a double layer of sticky-back foam had been attached to the flat surface on the meeting rail to simulate a bevel surface so that the air gap between it and the upper sash bevel would be closed. At this point, I realized that these sashes were actually upper sashes that had been converted to lower sashes thereby making these windows fake 9 x 9's. [Note: this doesn't rule out the possibility that the actual original lower sashes were also 9-lites.] This meant that something had happened to the original lower sashes that required this not-very-simple change to these upper sashes so they could be used as lower sashes. I thought that possibly they had rotted beyond repair, but discounted that since the side and bottom jamb surfaces where the lower sash would rest had no evidence of similar rot.

Since I had not removed Window 3 yet, I returned to the house to see if its lower sash was in the same condition as Windows 1 & 2. In fact it is, and I took some photos (attached pages) showing the upper and lower rope channels in the stile, the fake outward facing bevel using foam tape, the added strip of

At this point, I notified Paul that the lower sashes of the 9 x 9's were actually converted upper sashes from some other windows (possibly from a different house). Since this negated them as being a true "restoration", I felt we needed to consider a better plan of action. For instance, since other windows in the house had lower sashes that were 1-lite, perhaps these Windows 1 thru 3 had also had 1-lite lowers. However for the windows to all be consistent, why did some other windows have 1-lite uppers? Could it be that the 1-lite uppers (Windows 4 thru 6) were not original? This possibility was checked and some differences were noted but they would need to be removed for closer inspection and measurement to confirm. This led me to conclude that the lower (converted) 9-lite sashes in Windows 1 thru 3 in all probability had originally been the upper sashes in Windows 4 thru 6. This would at least provide all 7 original windows in the house with consistent 9-lite uppers!

Upper & Lower Rope Channels

1. Restore Windows 1 thru 3 upper sashes as is.
2. Restore and convert one of the Windows 1 thru 3 lower sashes back to its original upper sash condition and use it in Window 4.
3. Restore Window 4 lower sash as is.
4. Restore and repair as needed the 3 lower sashes in Windows 5 thru 7 and use them in Windows 1 thru 3.

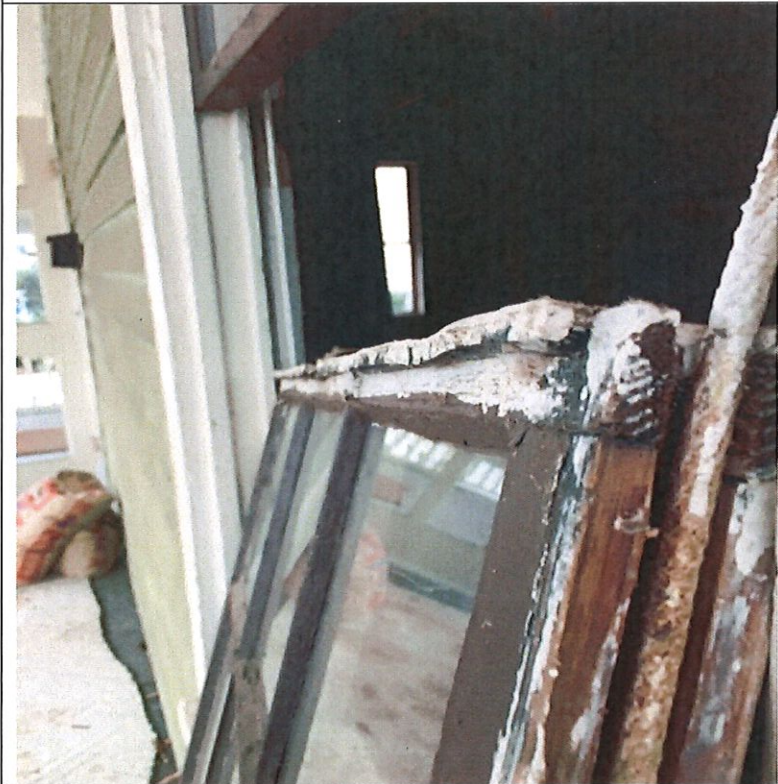
wood at the bottom rail to increase its width, and the actual meeting rail bevel facing inward and thus serving no function.

Fake Bevel Using Foam Tape

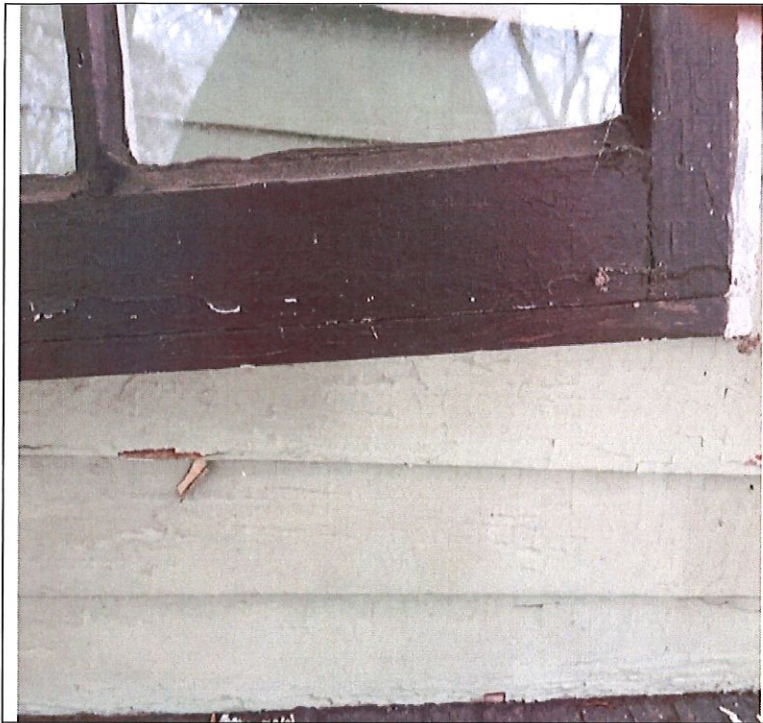
Bottom Rail With Added Wood Strip

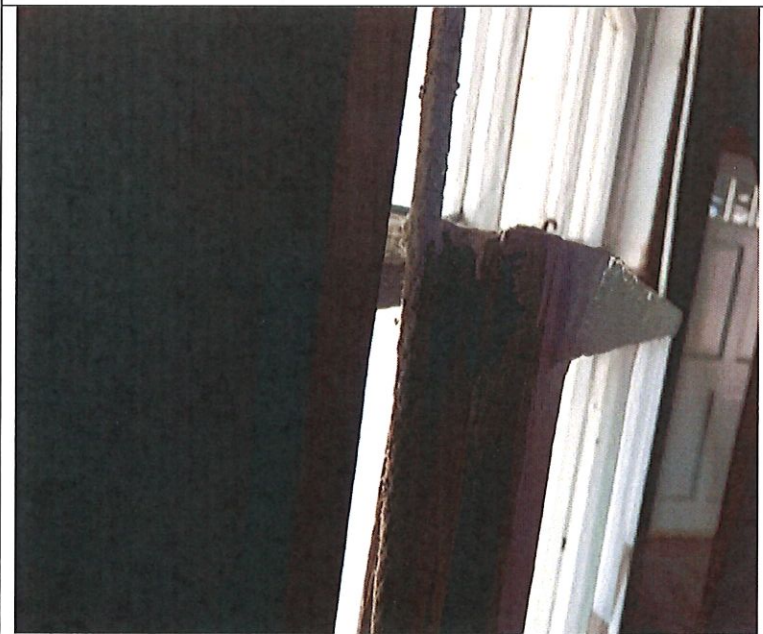
Meeting Rail Bevel Facing Inward
