CERTIFICATE OF APPROPRIATENESS PLACARD

317 S BOYLAN AVENUE

Project Description:

- Remove and replace existing windows
- Install new windows and door

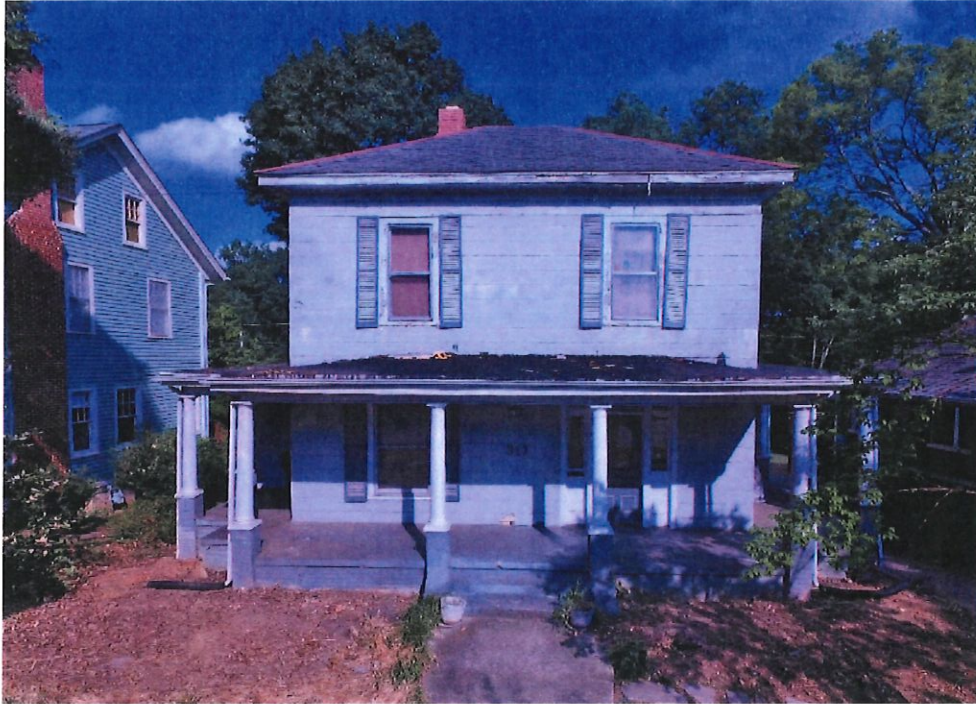
WEST (FRONT)

3. Existing structure prior to beginning rehabilitation work on approved CoAs

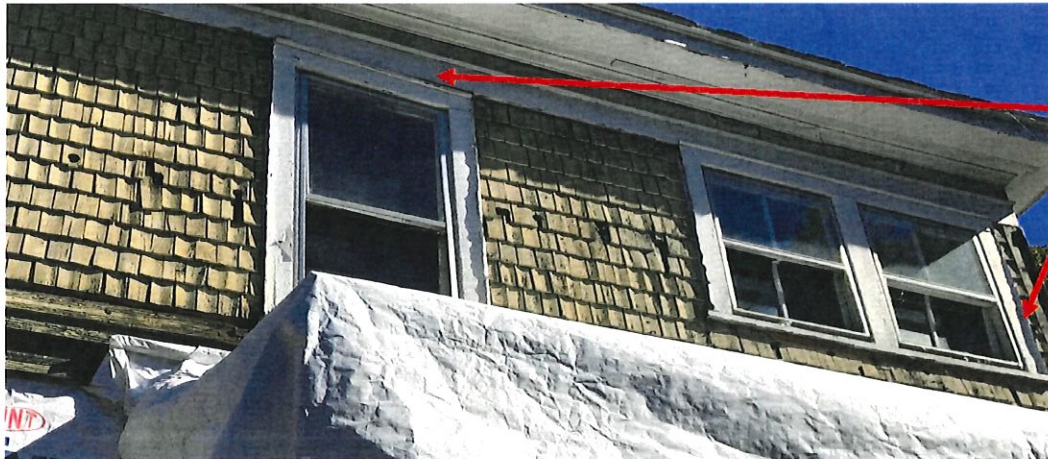
Windows on all sides of the house suffer from rotten wood, mold/mildew, being warped/out of square, etc. In several locations, only the non-historic storm windows remain intact; in some locations, even the storm windows are warped, missing glass, etc. (Note that with window replacement all storm windows will be removed).

Below: South façade, note the port holes where urea-formaldehyde foam was blown in and warped upper windows.

Warped, out of square windows

In summary: per Guidelines 3.7.6 and 3.7.7, due to the windows' condition, the rot, mold, and deterioration caused by relentless water damage, along with the toxicity of the materials used in and around the window cavities and the length of time these toxic substances were left to penetrate the window wood along with years of unabated water damage, the windows are deteriorated such that no existing double hung windows can be salvaged. The homeowners strongly believe that the safest plan for both the structure and the family is to seal the cleaned structure with polyurethane closed cell spray foam and replace windows per the RHDC Design Guidelines.

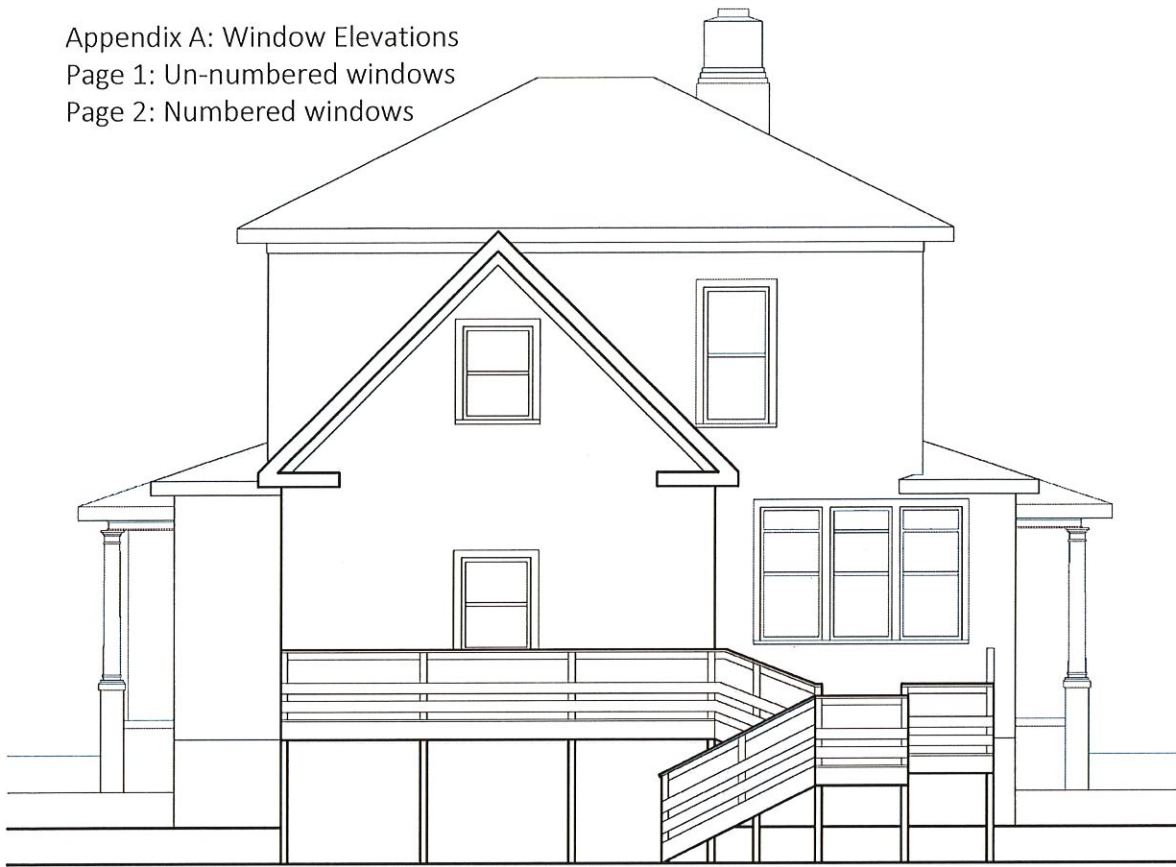
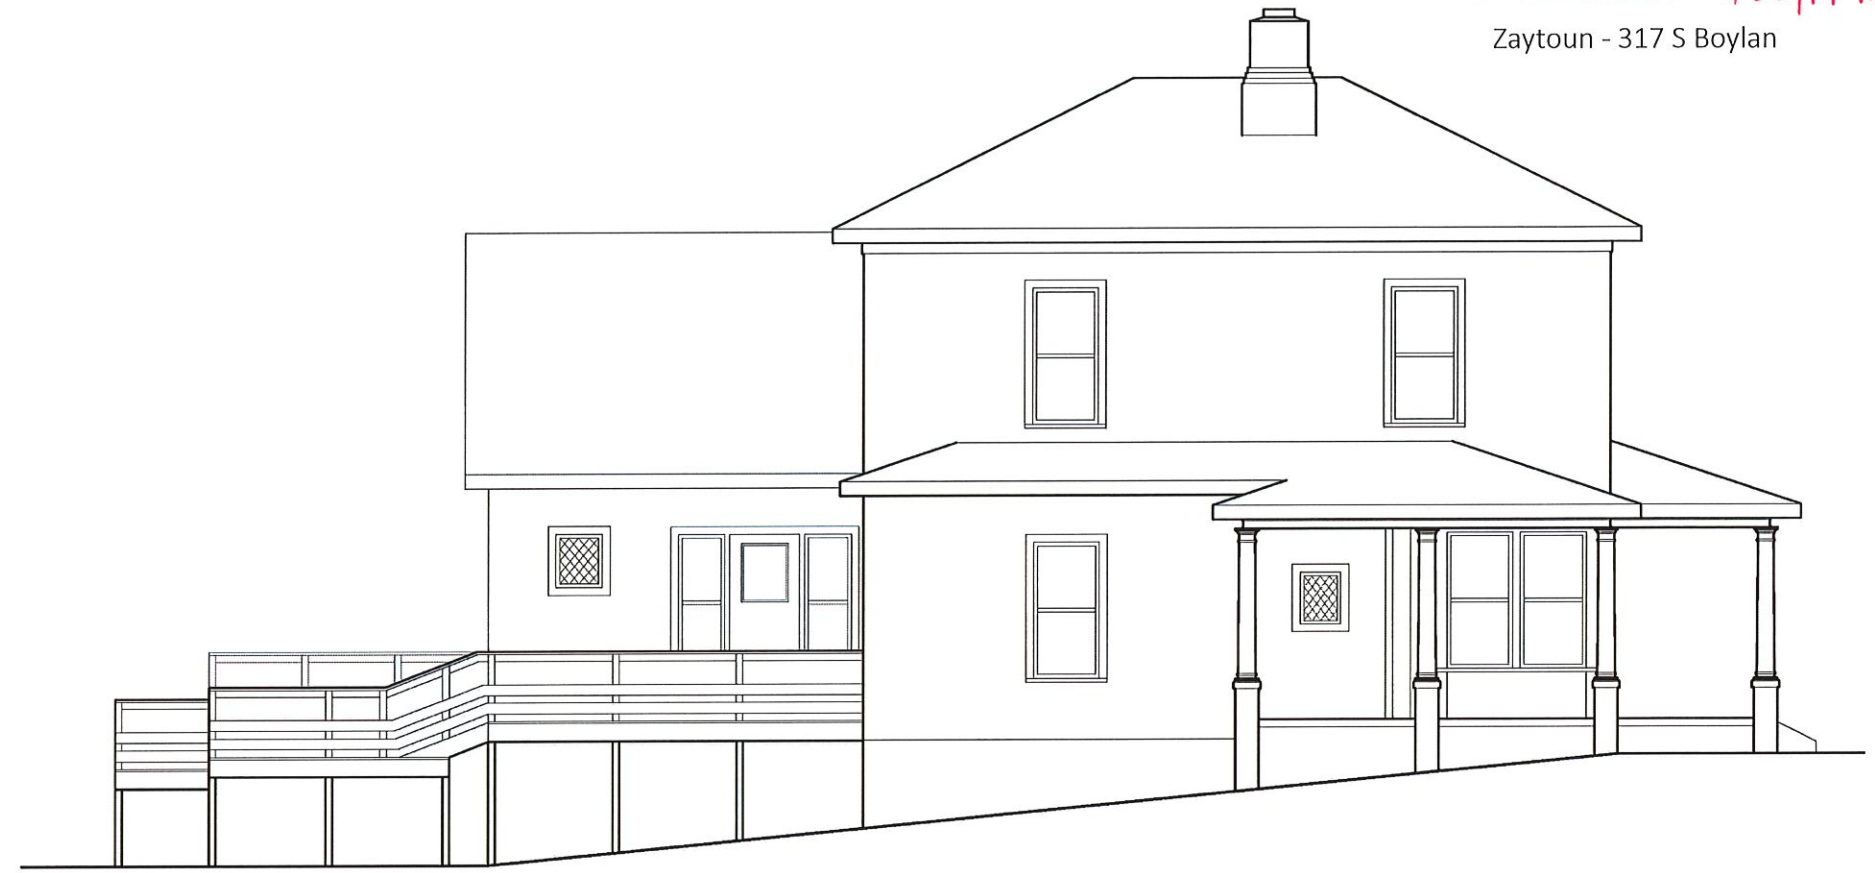
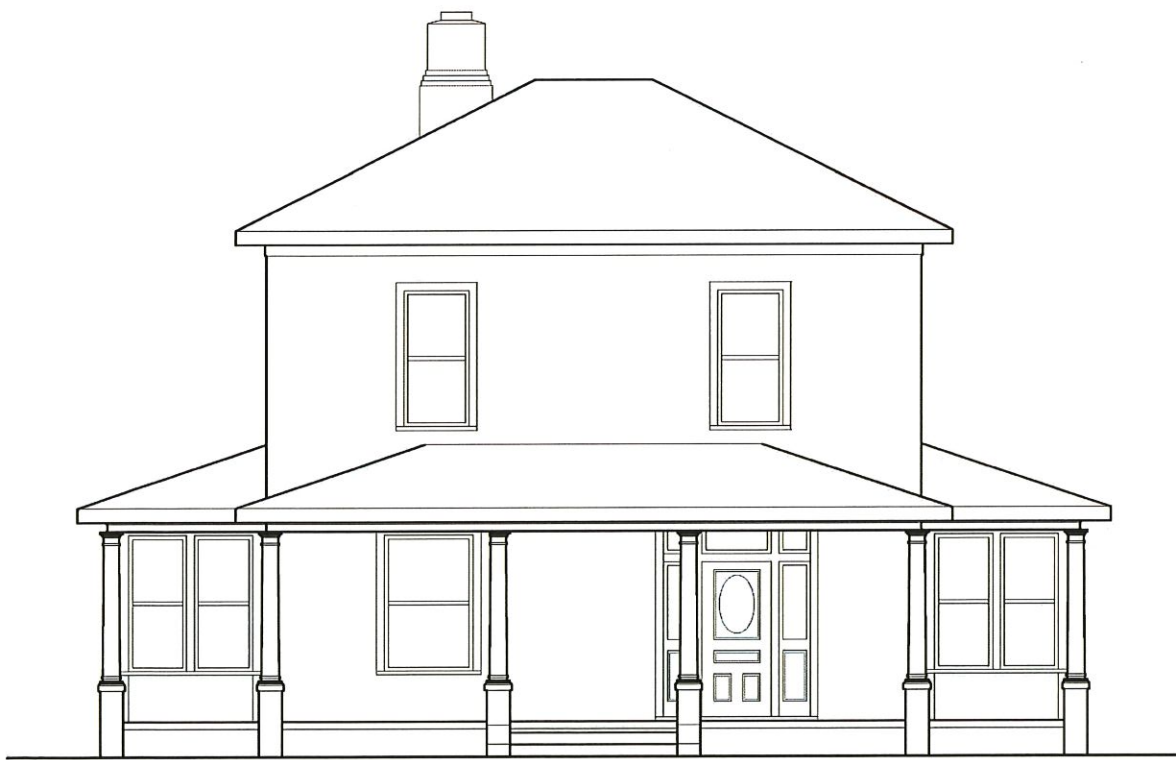
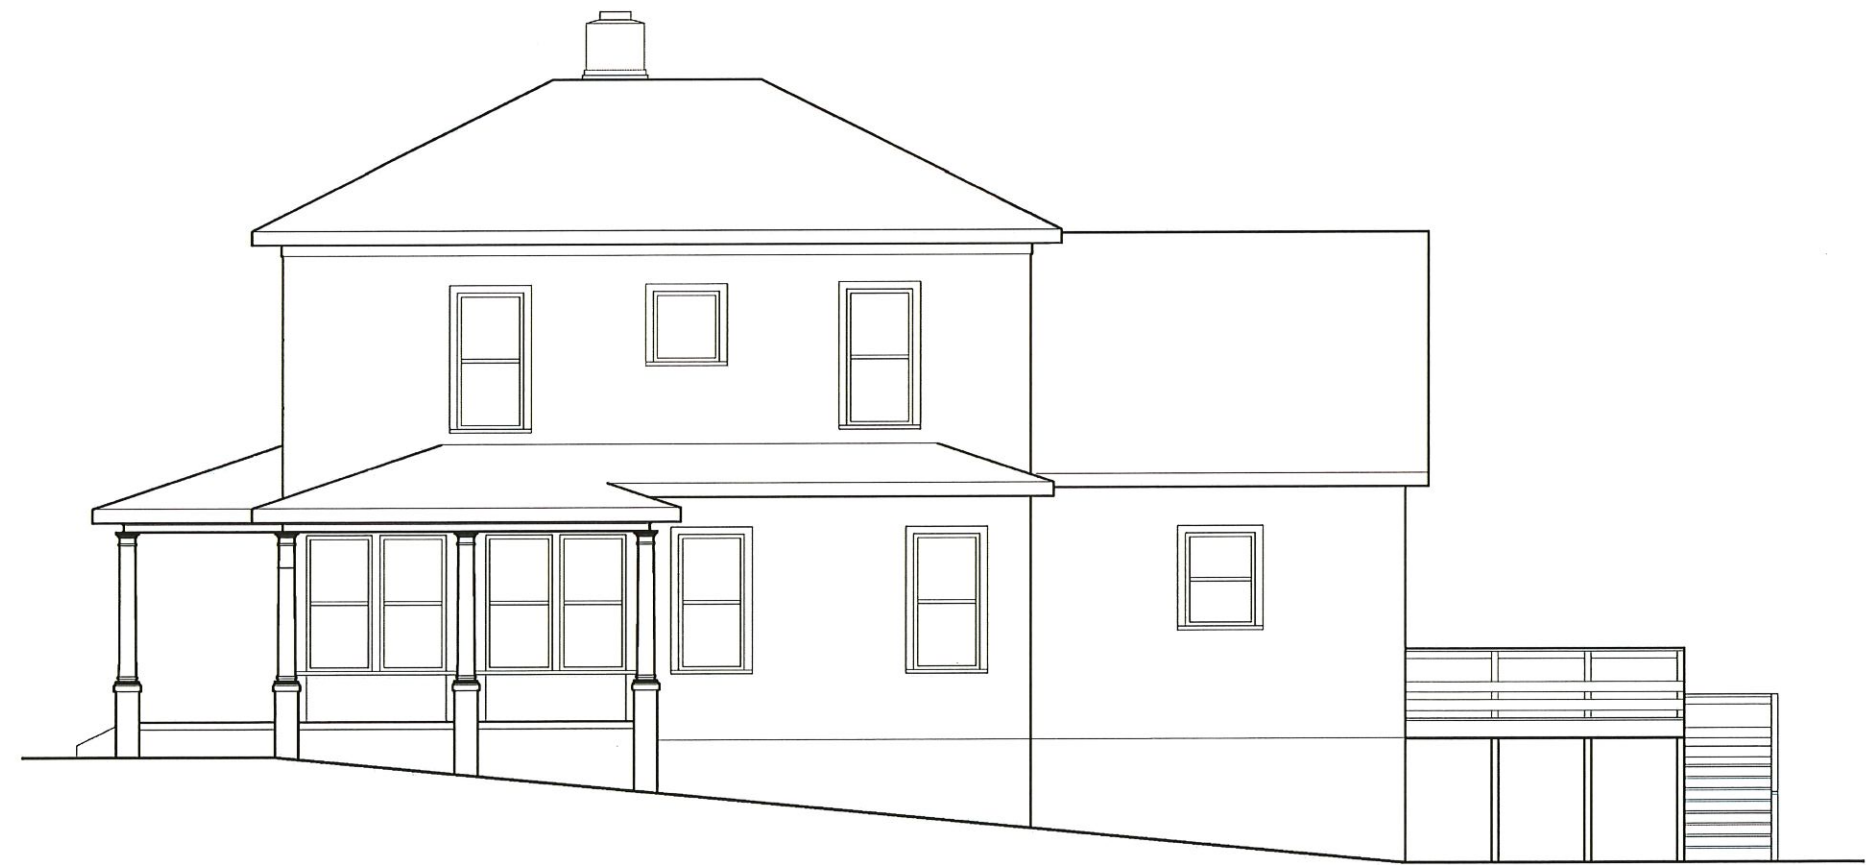
Appendix A: Window Elevations
Page 1: Un-numbered windows
Page 2: Numbered windows

5. Current window condition: photographs
6. Proposed windows: marked-up photos showing windows to be replaced, removed, or added. Proposed windows (either replaced, remaining, or added) are numbered for reference, corresponding with elevations and window specifications

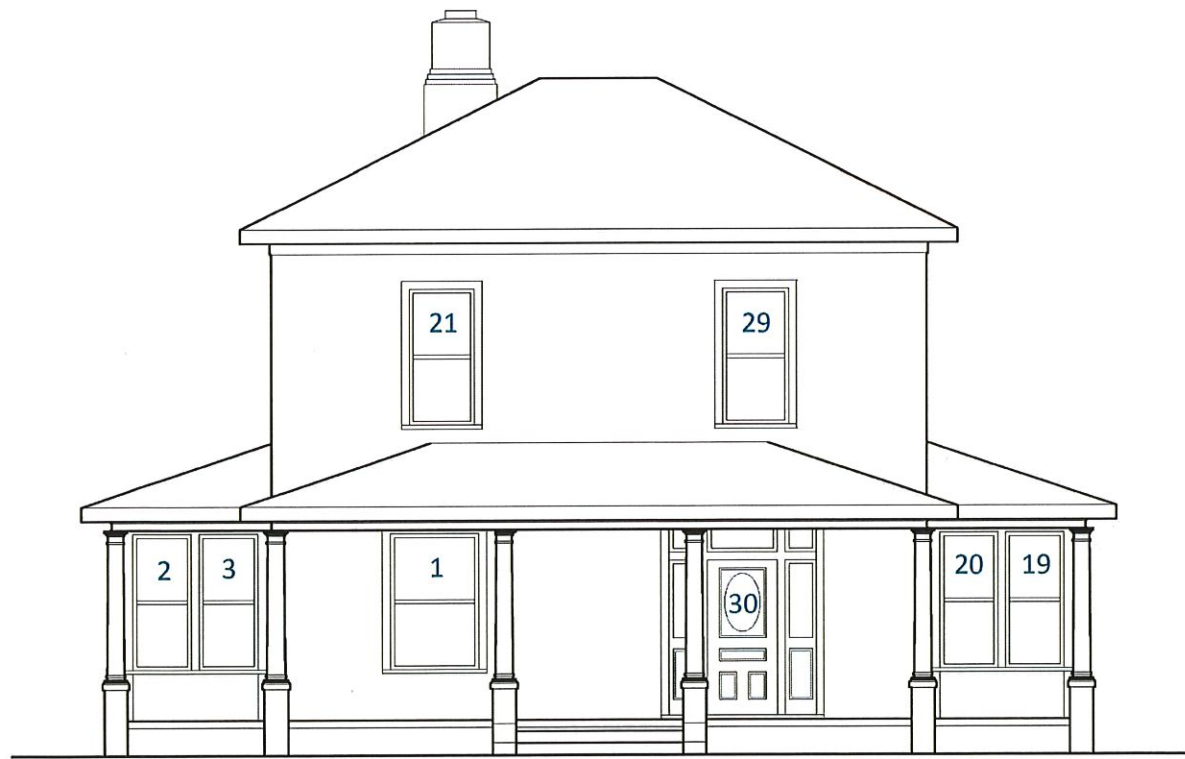
Front (West)

The front façade of the house will remain unchanged in appearance: Double-hung wood windows that are the same size as the existing windows will be hung in the exact same locations. The front door and sidelights (one oval glaze in door and five sidelights) will be restored and re-used (per 3.7.2)
